BELL AEROSPACE TEXTRON BUFFALO N Y  
LACV-30 AUXILIARY POWER UNIT INVESTIGATION.(U)  
JUN 77 R P KAISER  
7467-927024

LACV-30 AUXILIARY POWER UNIT INVESTIGATION

Final Technical Report for Period September 1976-January 1977

This report documents the results of an intensive investigation to determine the cause of a series of T-62T-32-3 engine failures in the Auxiliary Power Unit (APU) on the LACV-30 vehicles, and to develop a solution to the problem.

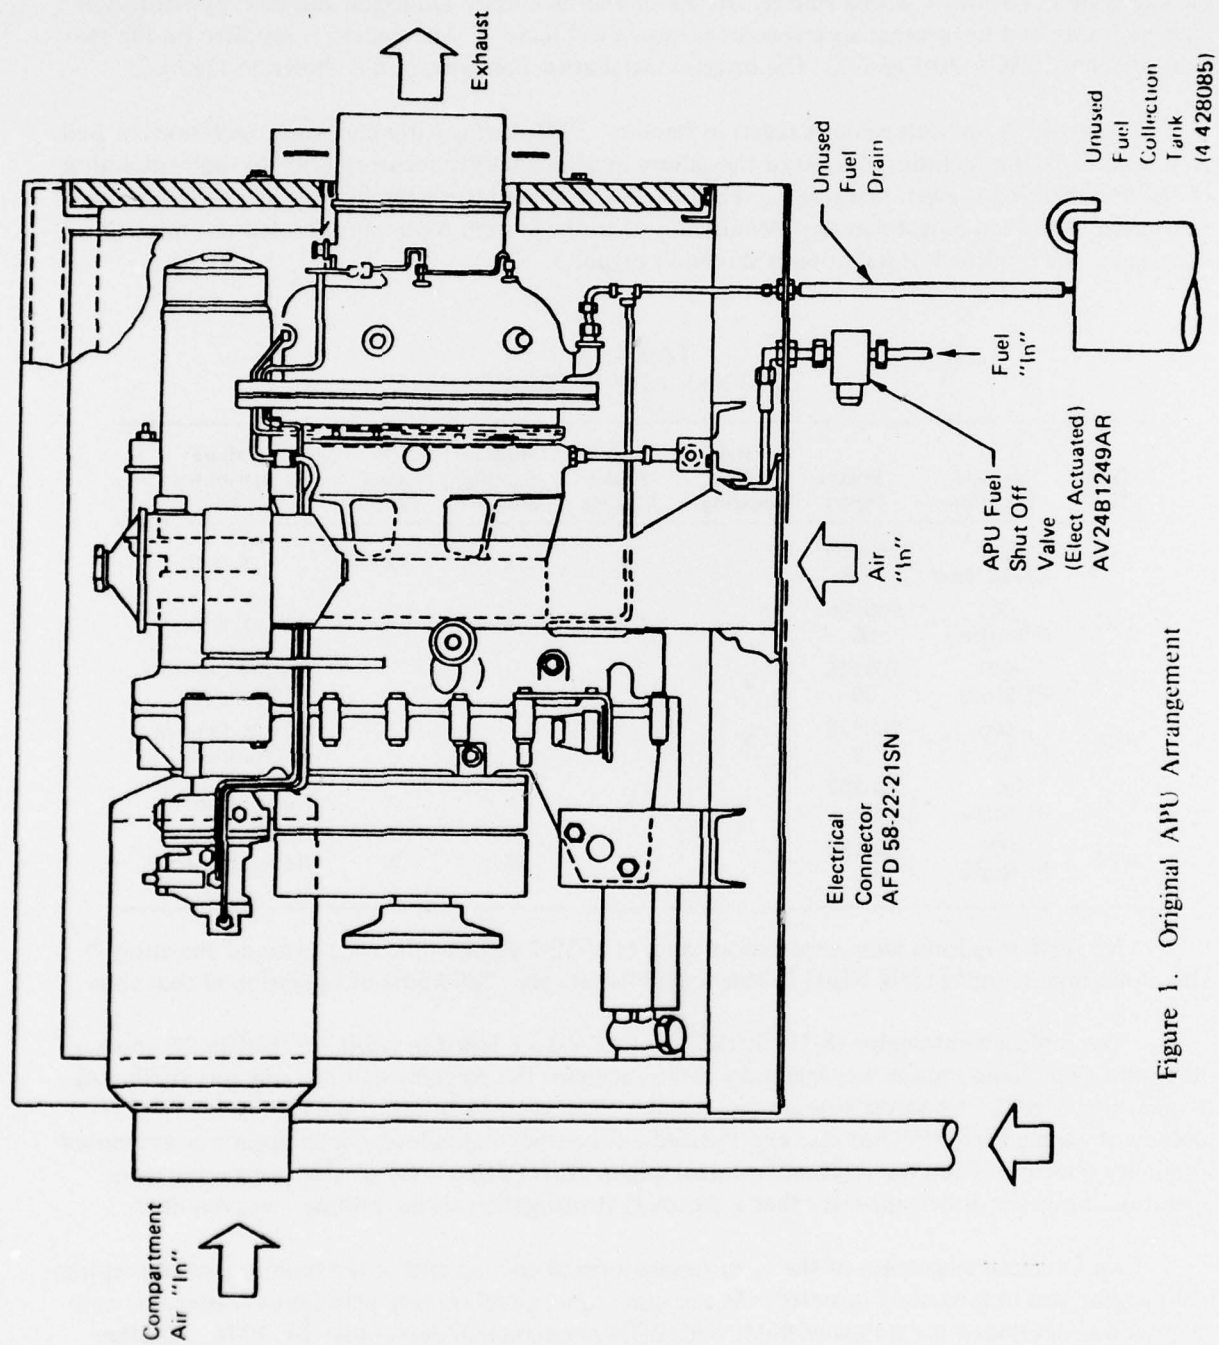
Figure 1. Original APU Arrangement

It is concluded that the original APU module arrangement reinforced or excited engine rotor shaft 1F vibrations to potentially destructive amplitudes, and that the vibration was the probable cause of most or all of the LACV-30 APU failures.

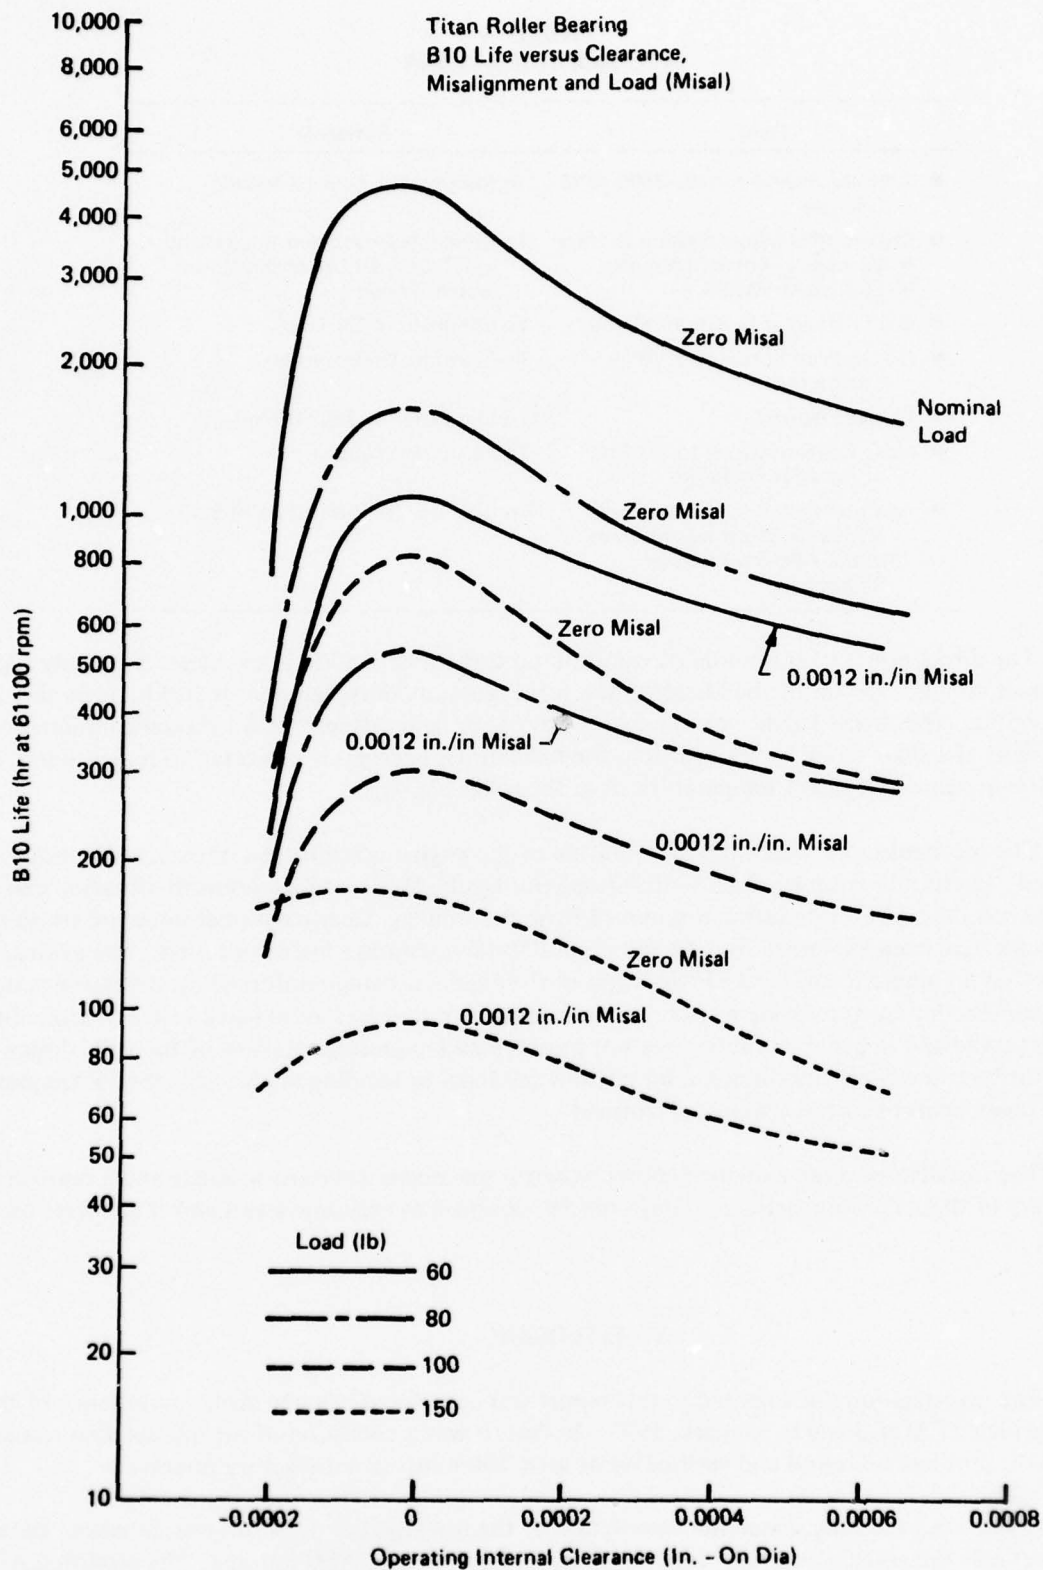
Figure 6. Bearing Life Chart

Evidence that the levels of excursion measured are destructive to the roller bearing is ample. The rise in bearing race temperature invariably accompanying the vibration is an indication that the bearing is absorbing more energy, either from skidding or from induced misalignment, even though the temperature levels are not destructive of themselves. The presence of 5-mil peak-to-peak excursions at the bearing support snout results in peak loads on the bearing on the order of 200 pounds, at the support spring rate of 80,000 pounds per inch. As may be seen from the bearing life chart of Figure 6, loads of this magnitude combined with misalignment result in bearing life measured in hours rather than thousands of hours.
